**Monitoring report form for CDM project activity
(Version 09.0)**

Title of the project activity	Reducing Gas Leakages within the Jalalabad Gas Distribution Network in Bangladesh		
UNFCCC reference number of the project activity	10561		
Version number of the PDD applicable to this monitoring report	Version 4		
Version number of this monitoring report	2		
Completion date of this monitoring report	07/12/2021		
Monitoring period number	2		
Duration of this monitoring period	30/10/2020- 31/12/2020 (Including both days)		
Monitoring report number for this monitoring period	1		
Project participants	EcoGas Asia Ltd.		
Host Party	People's Republic of Bangladesh		
Applied methodologies and standardized baselines	Leak detection and repair in gas production, processing, transmission, storage and distribution systems and in refinery facilities" AM0023 (Version 04.0.0) No standardized baseline was applied		
Sectoral scopes	Sectoral Scope 10 – Fugitive emissions from fuels (solid, oil and gas)

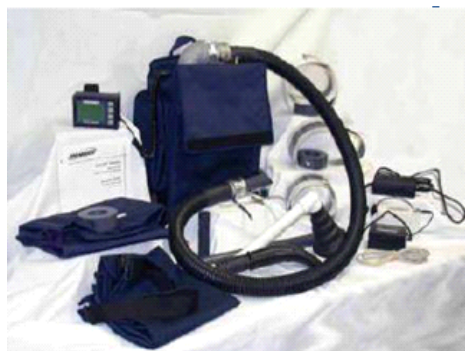
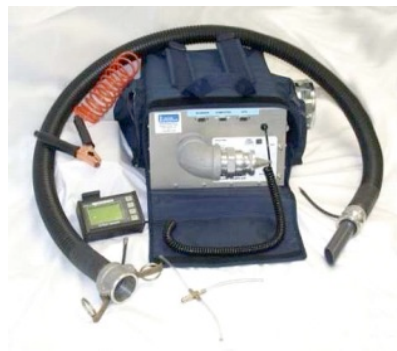
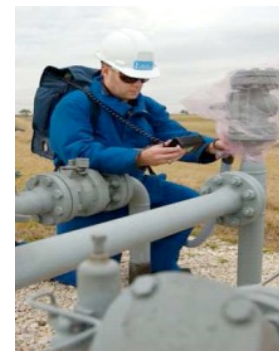
High Flow Sampler

Gas Surveyor 500

- The measurement method (Leaks may have been initially detected using Gas Surveyors. Once a leak was detected, all measurements for leak flow rate were taken using Hi-Flow Samplers, each Hi-Flow Sampler unit was assigned a number and the unit responsible for each measurement was thereby recorded. Furthermore, Hi-Flow Samplers recorded each measurement with a number between 1 and 999; the number corresponding to each measurement of leak flow rate is recorded in the Project Database. After the leak was repaired, the Repair Team used a soap solution to check the quality of the repair.
